## Contract in Brief

Ferrybridge Power Station

SSE

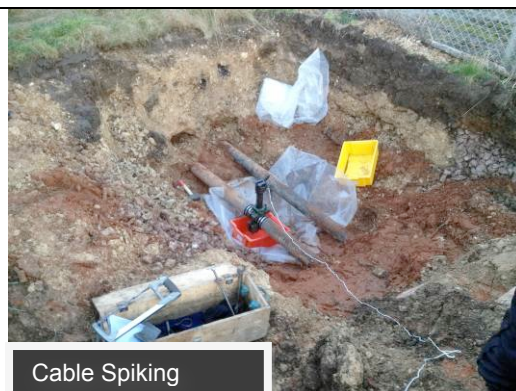
Cable Spiking

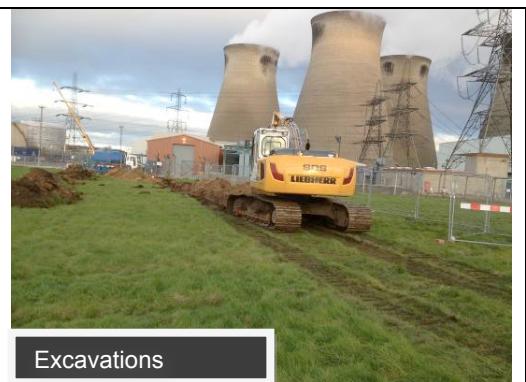
Excavations

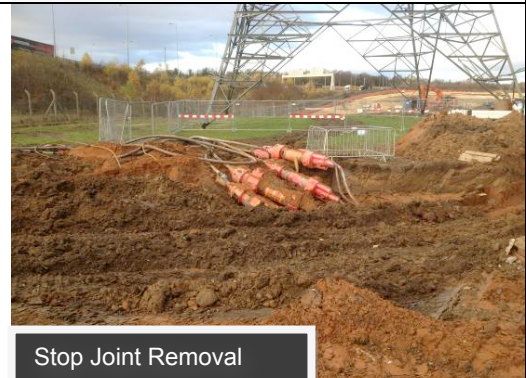
Stop Joint Removal
